**Specific Site Assessment for  
Coal Combustion Waste  
Impoundments at Duke  
Energy Indiana (DEI)  
Cayuga Generating Station**

Cayuga, Indiana

September 2010  
Project 092882

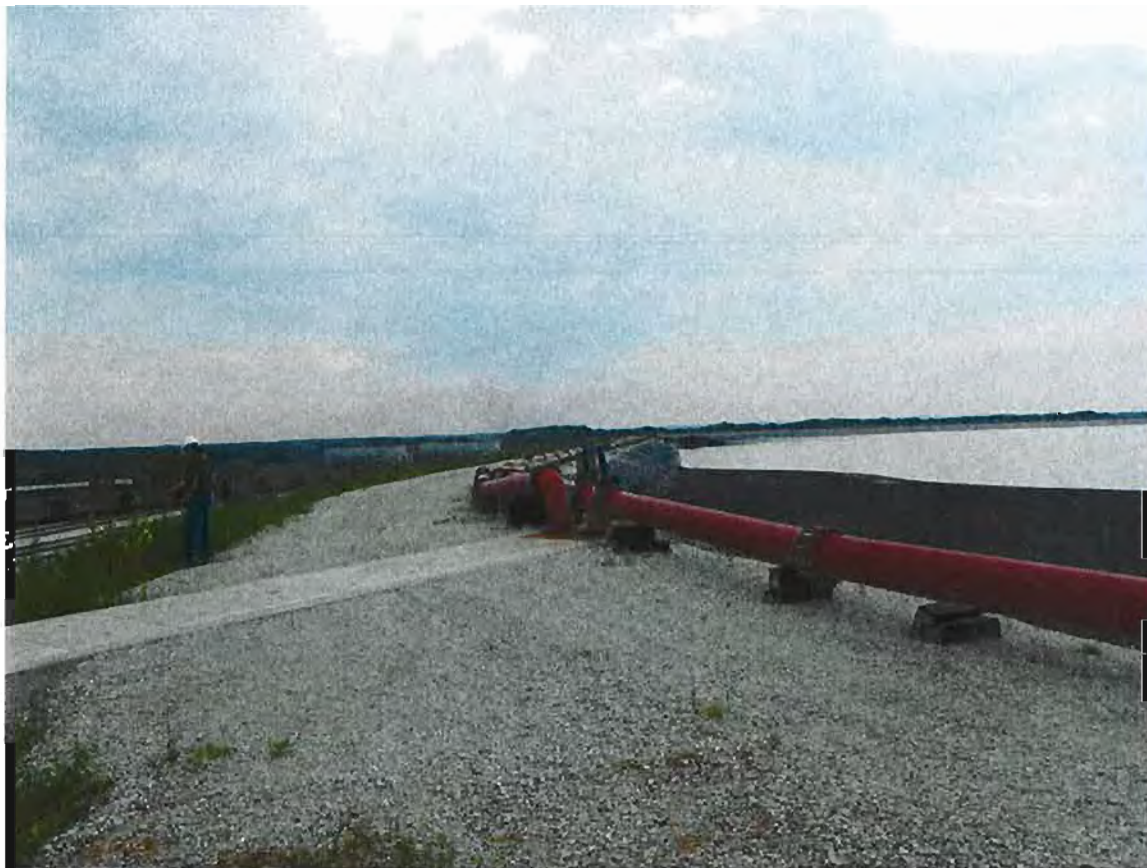
**Photo 1: Lined Ash Disposal Pond – Cell #1 - North dike upstream slope and crest, looking east**

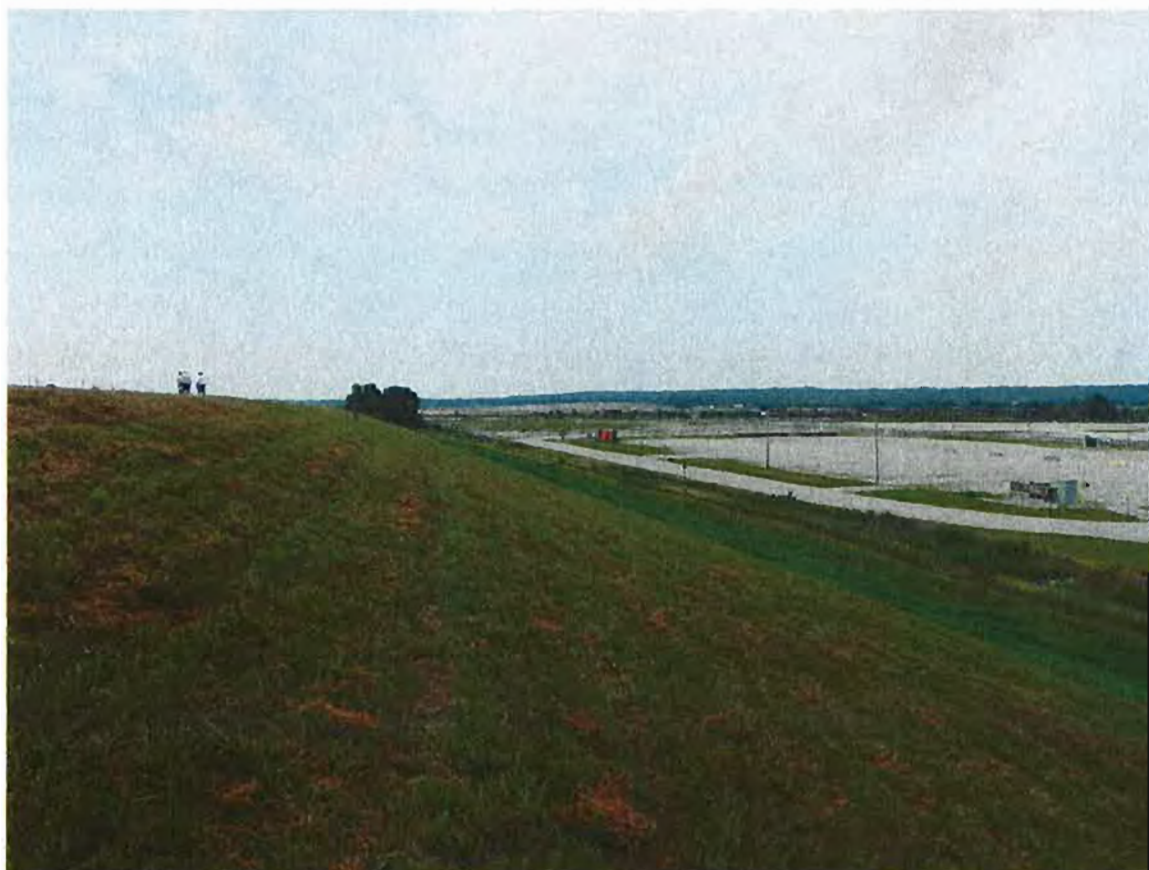
**Photo 2: Lined Ash Disposal Pond – Cell #1 – West dike downstream slope, looking southwest**

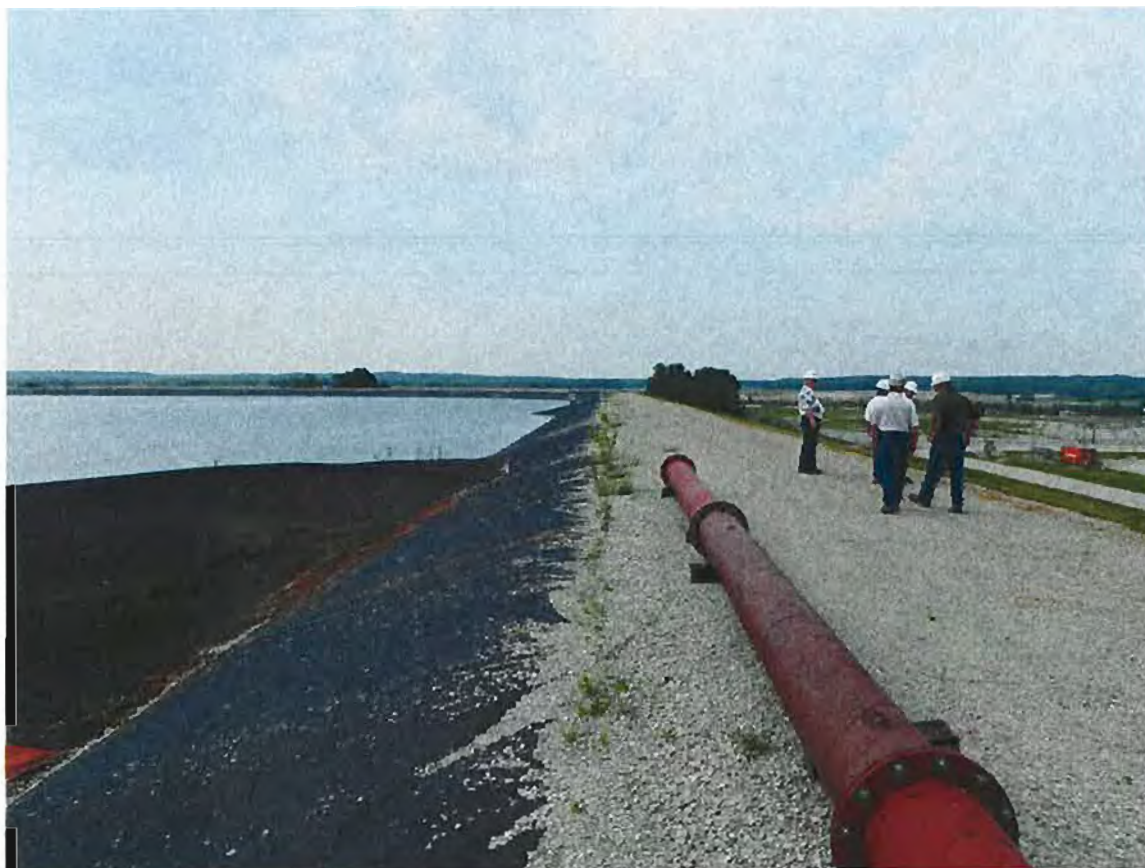
**Photo 3: Lined Ash Disposal Pond – Cell #1 – West dike upstream slope, looking south**

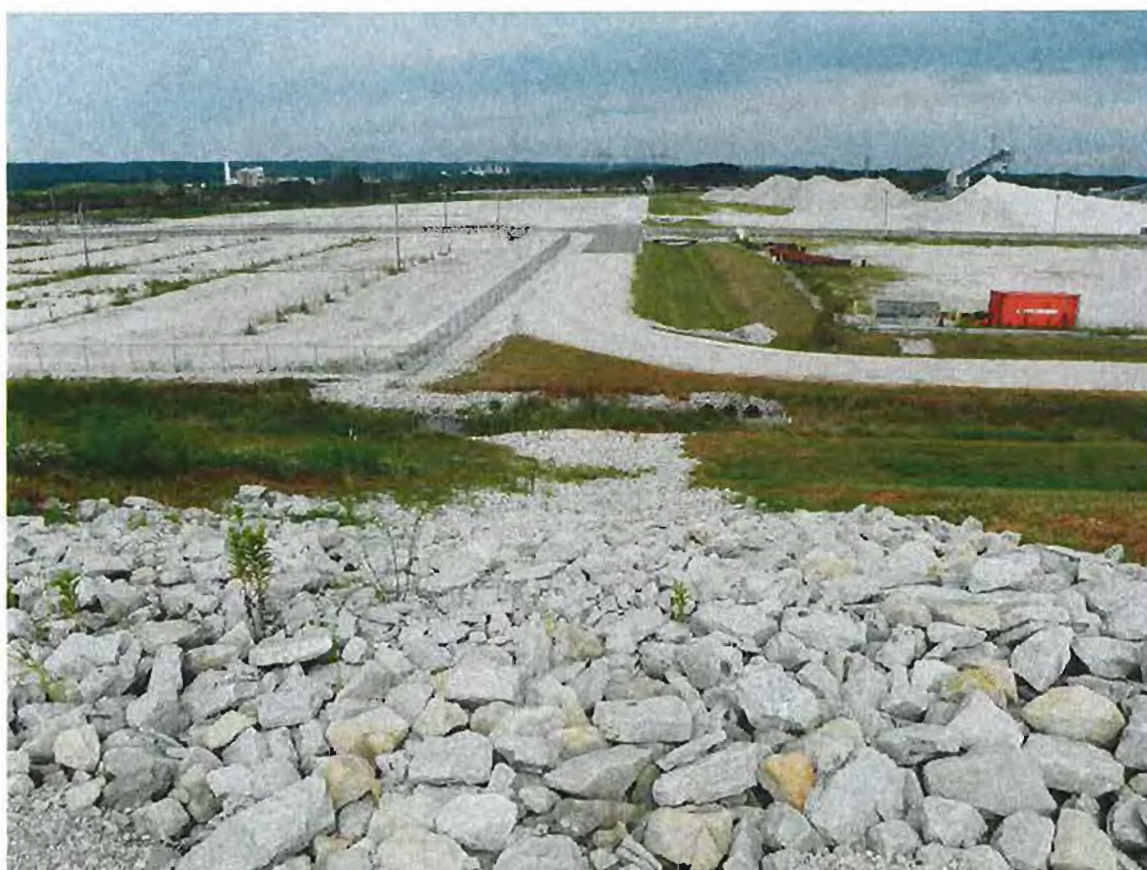
The Lined Ash Disposal Pond – Cell #1 emergency spillway is in good condition. A minor amount of vegetation was observed growing through the riprap in the channel.

**Photo 4: Lined Ash Disposal Pond – Cell #1 – Emergency spillway, west dike, looking west**

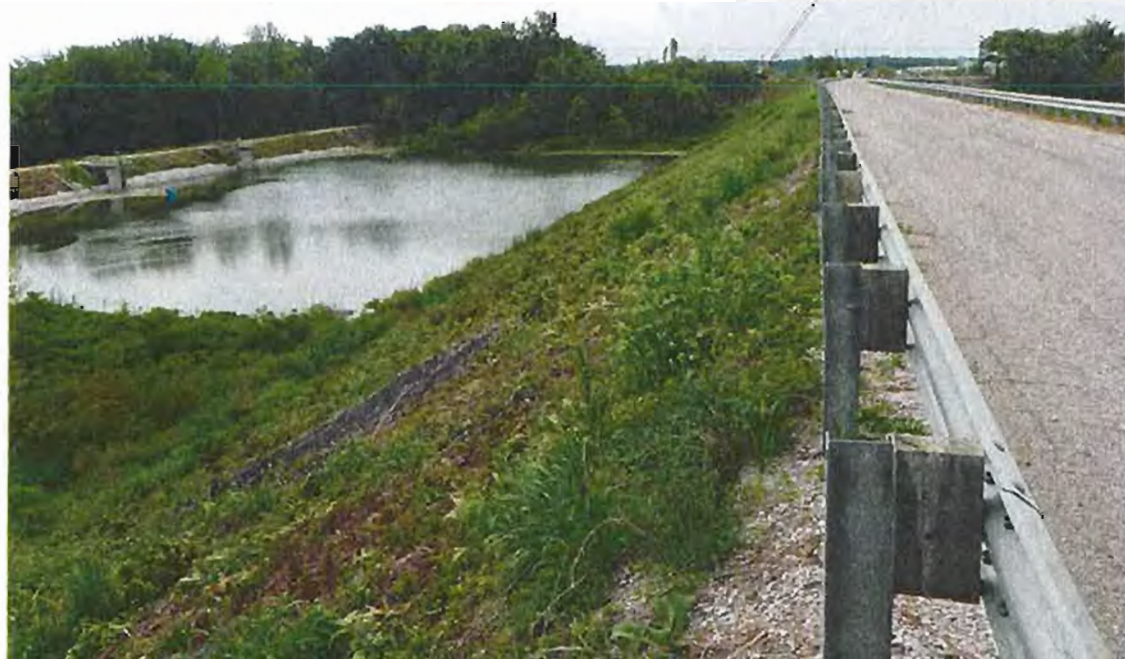
**Photo 29: Secondary Ash Settling Pond – West dike upstream slope (divider dike with Primary Ash Settling Pond), note erosion, looking south**

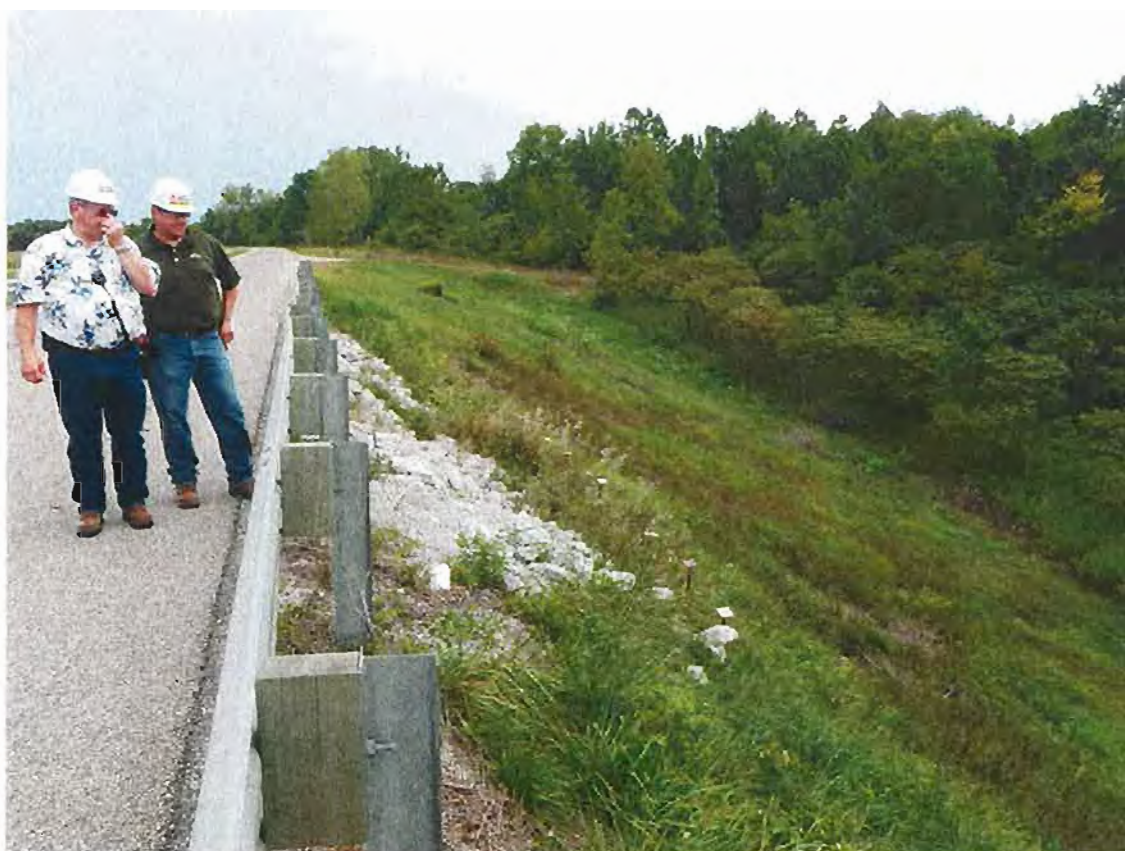
**Photo 30: Secondary Ash Settling Basin – West dike upstream slope (divider dike with Primary Ash Settling Basin), note erosion, looking north**

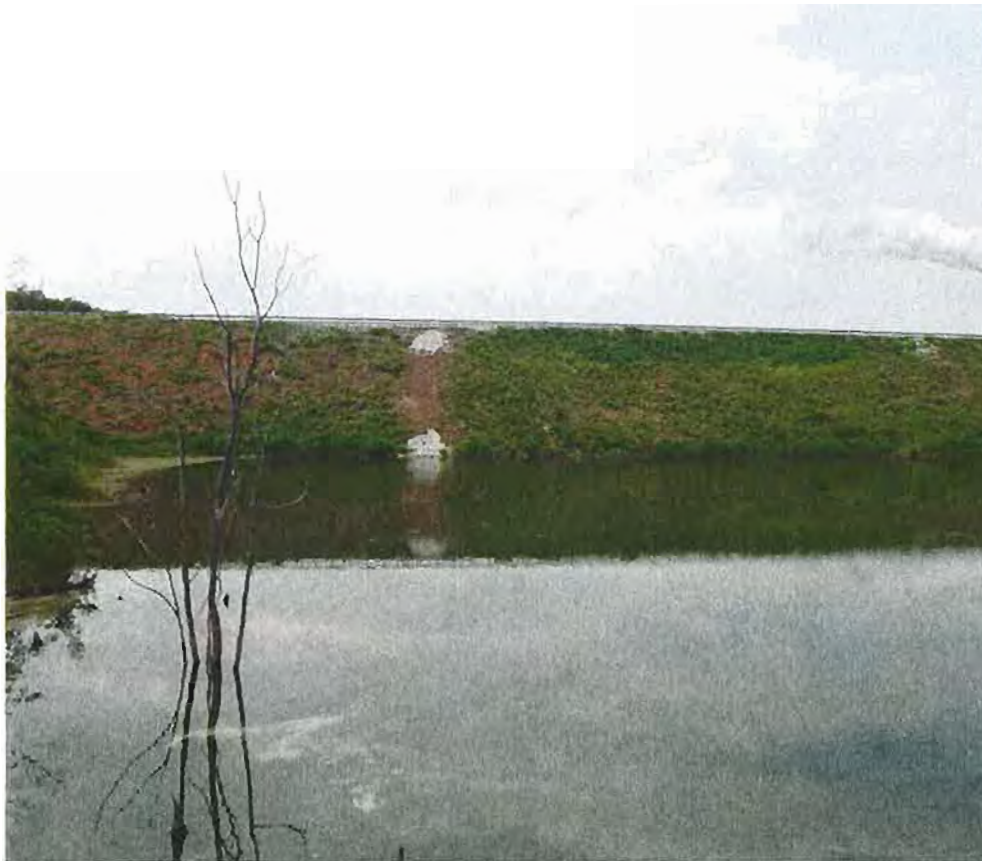
**Photo 32: Secondary Ash Settling Basin – West dike upstream slope, note rip rap covering animal holes, looking west**

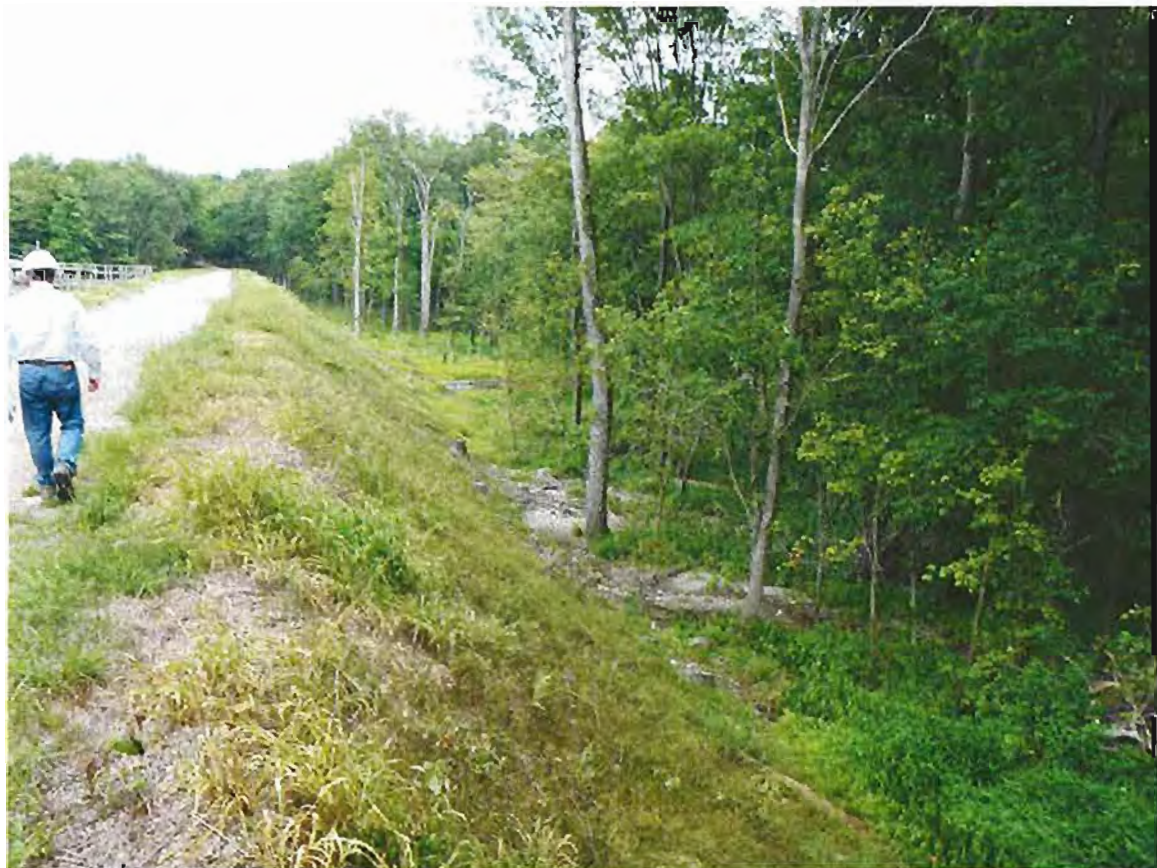
Several trees (up to 2-foot-diameter) were observed at the toe of the downstream slope of the Secondary Ash Settling Basin east dike and the Temporary Cover 2008 area of the Ash Disposal Area #1. A dense growth of large trees and shrubs were also observed on the downstream slope of the Original Ash Pond perimeter north dike, which forms the north dike of the Ash Disposal Area #1 and the supporting dike for the Lined Ash Disposal Pond – Cell #1 and its underlying older ash foundation.

**Photo 34: Secondary Ash Settling Basin – East dike downstream slope, note trees within 25' of dam toe, looking north**

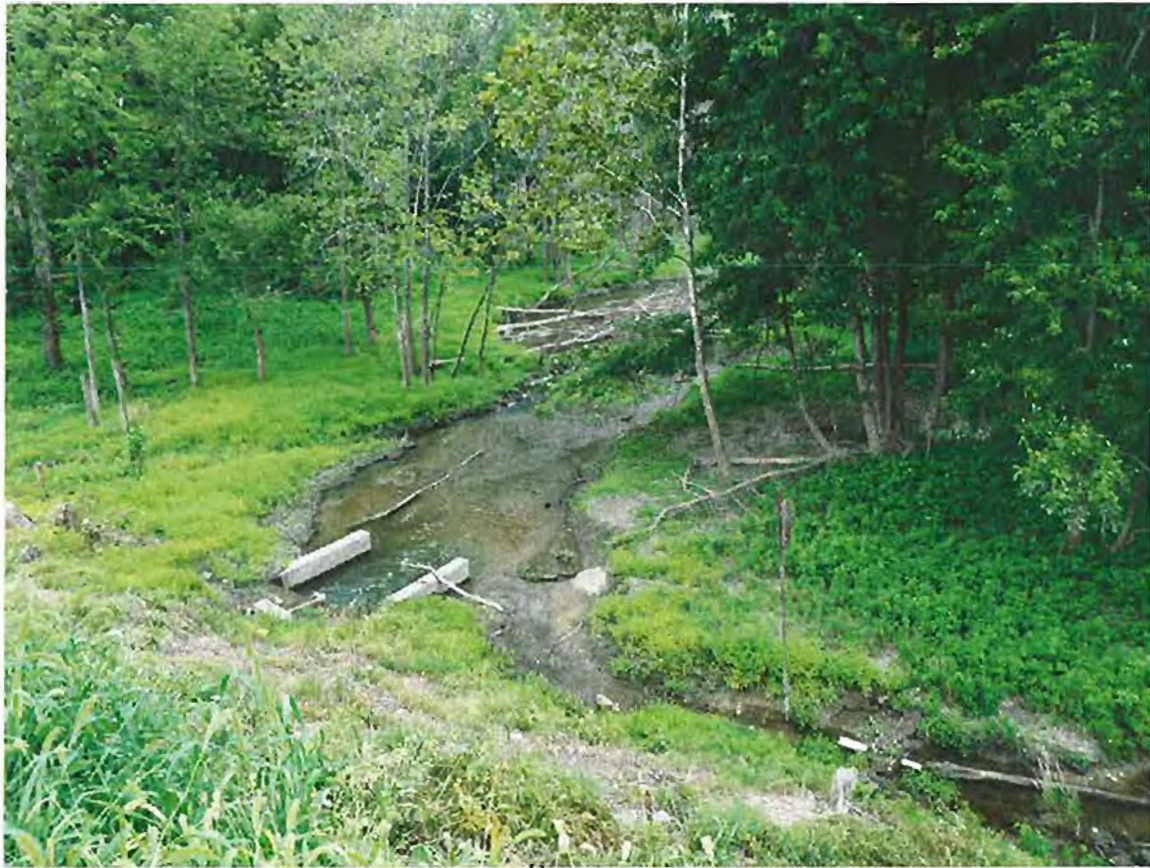
Foundation and/or embankment seepage was observed flowing at several gallons per minute at the downstream toe of the Secondary Ash Settling Basin east dike. The water was flowing clear at the time of the inspection. Duke Energy indicated the water has been seeping unchanged for many years. The seepage could be a result of seepage from the Primary Ash Settling Basin through the natural slope that forms the southern limit of the Secondary Ash Settling Basin and could be unrelated to the Secondary Ash Settling Basin east dike, or could

**Photo 35: Secondary Ash Settling Basin – East dike downstream toe, outlet and outlet structure to Wabash River, note seepage along downstream toe of dike at right side of photo, looking northeast**

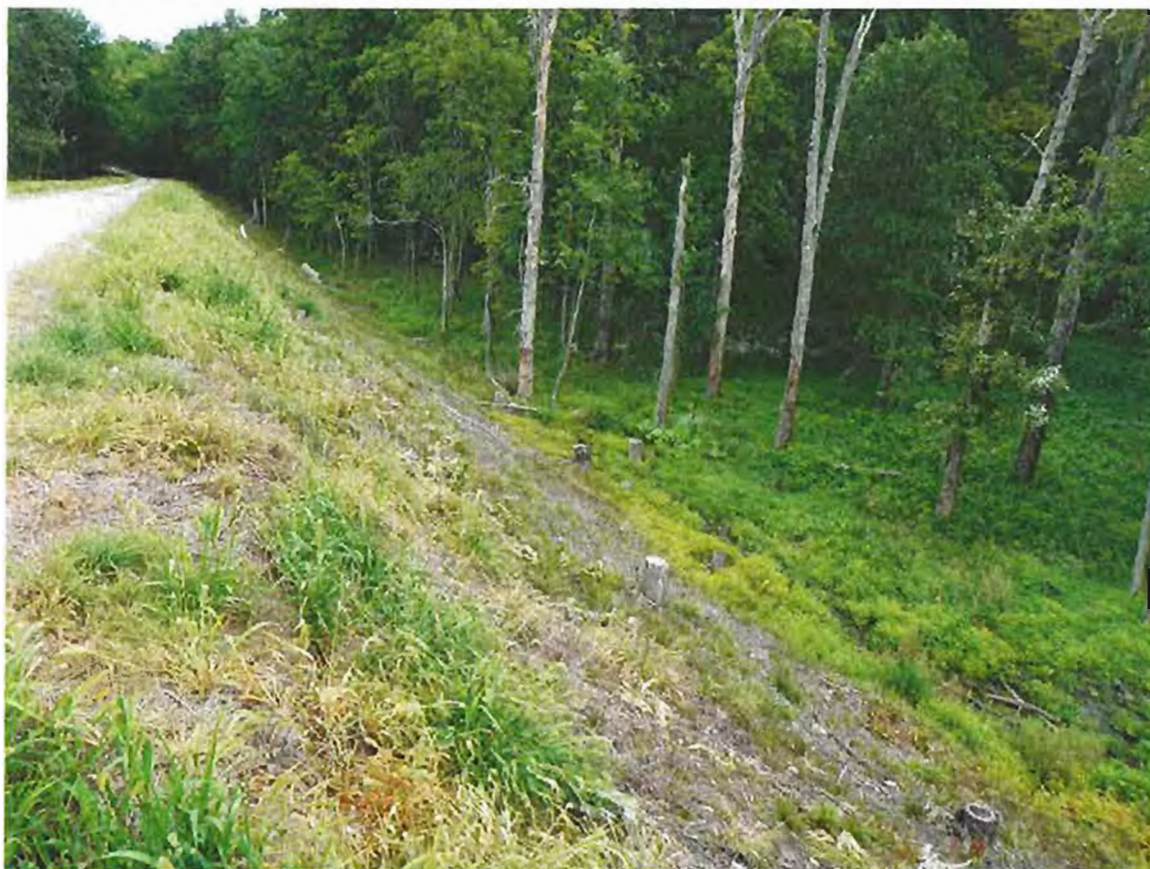
Photo 38: Secondary Ash Settling Basin – East dike downstream slope, note trees within 25' of dam toe, looking north

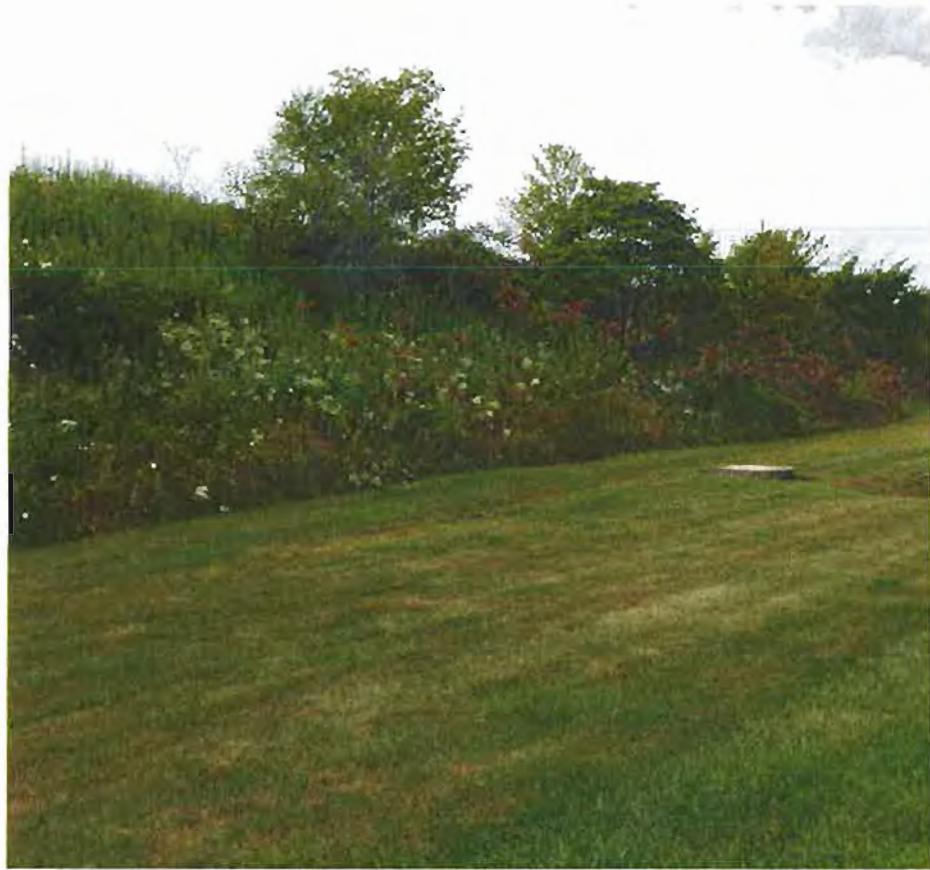
**Photo 39: Original Ash Pond – North dike downstream slope, note trees, looking southwest**

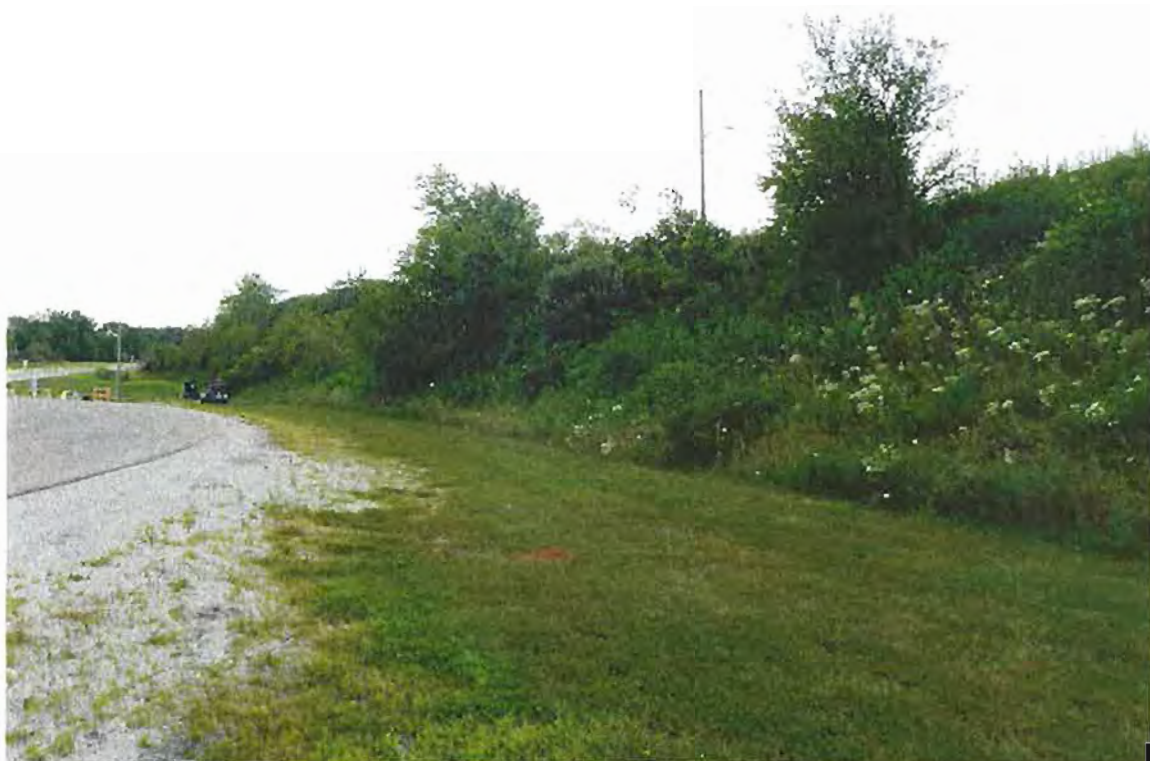
**Photo 40: Original Ash Pond – North dike downstream slope, note trees, looking east**

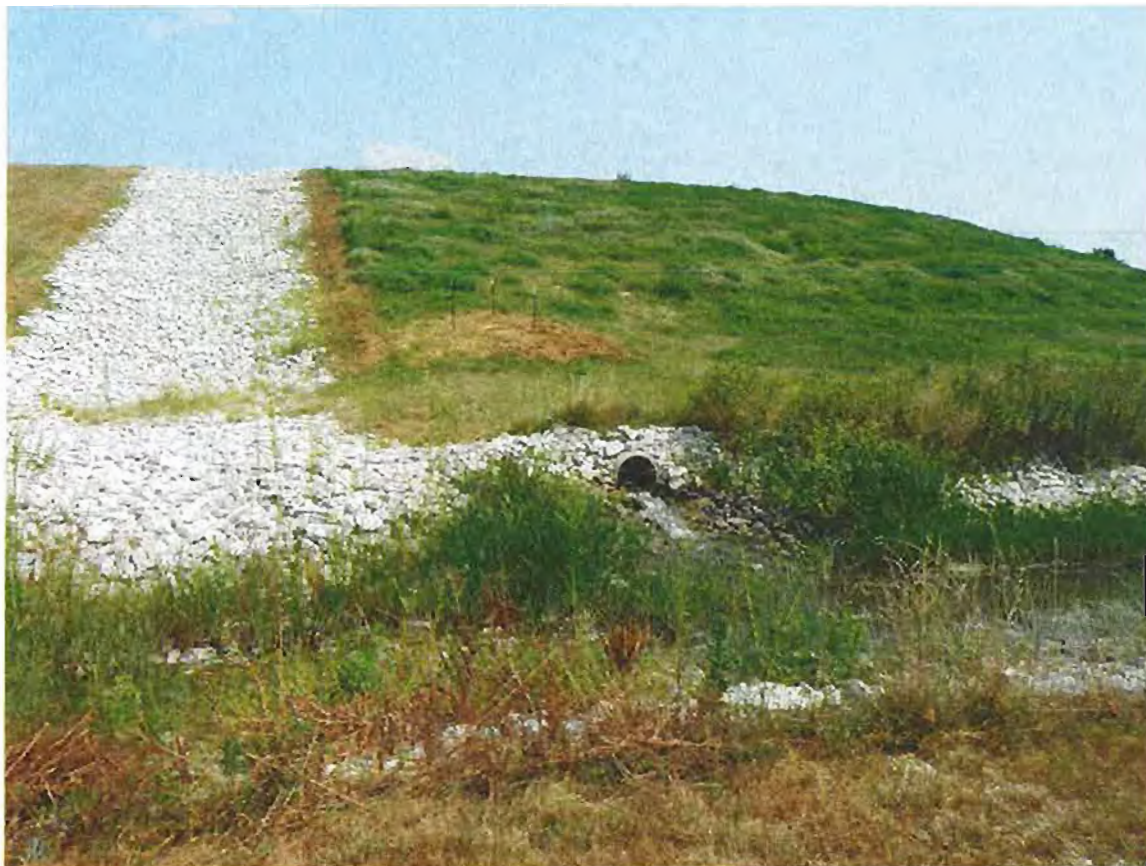
**Photo 41: Lined Ash Disposal Pond – Cell #1 – Emergency spillway and outlet pipe, looking east**

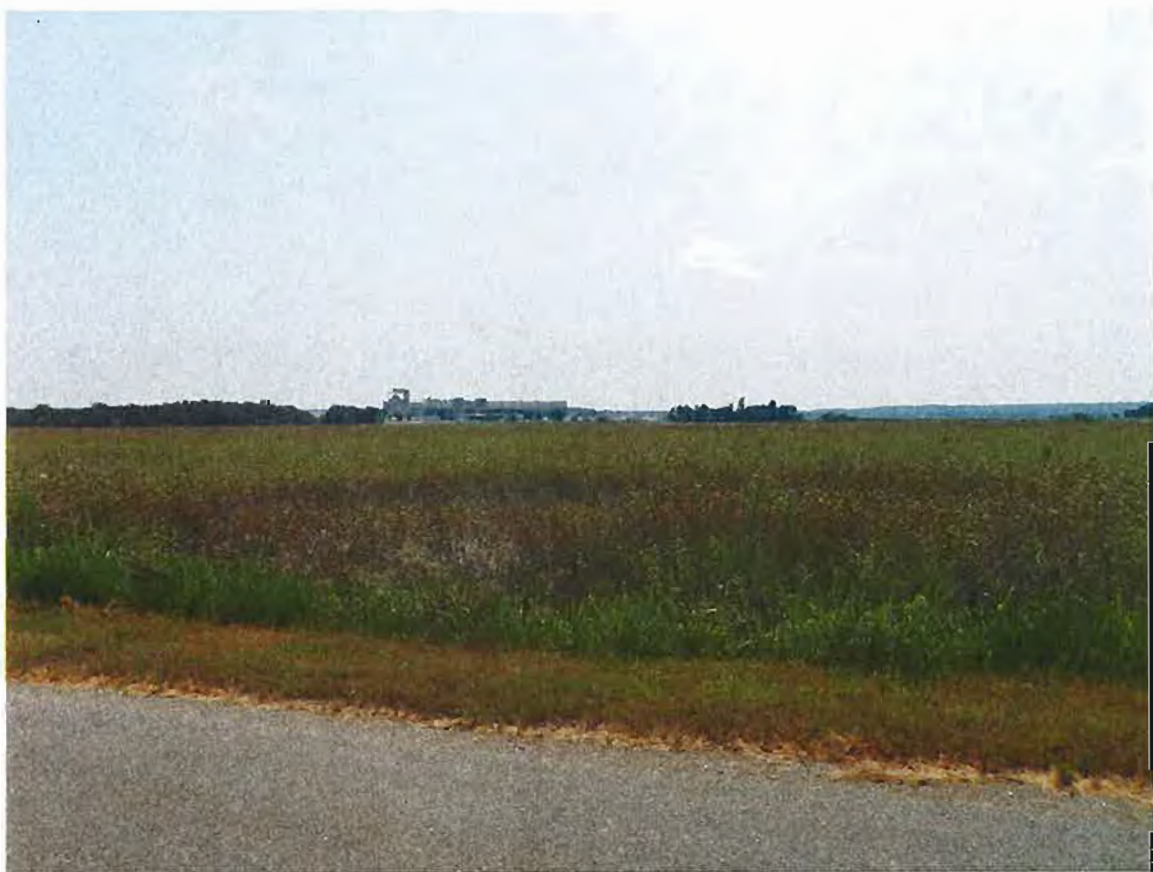
**Photo 46: Ash Disposal Area #1 – Temporary Cover 2008 area, looking southwest**

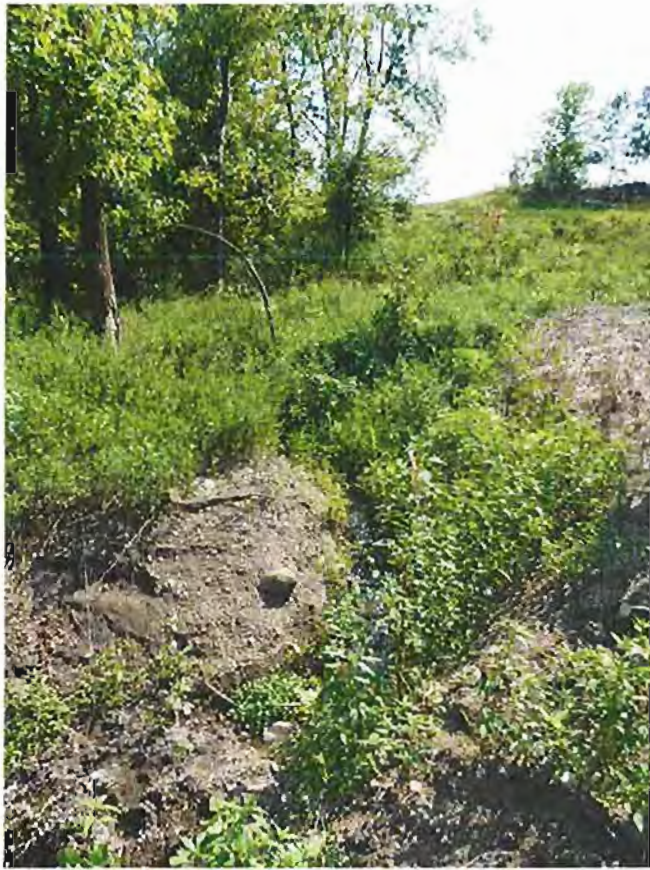
A seep and/or natural spring was observed at the natural hillside downstream of the northeast dike bounding the Temporary Cover 2008 area. Clear water flowing at a couple of gallons per minute was visible during inspection. Duke Energy indicated the seeps and natural springs daylight within the natural ground strata beneath the dike and have been observed since shortly after construction of the dike with no significant change. Duke Energy has recently begun monitoring the seepage and taking flow measurements. There were no visible signs of movement or other disturbance in the area of the seep/natural spring.

**Photo 47: Ash Disposal Area #1 – Downstream of northeast dike downstream toe, note seeps / natural springs, looking southeast**

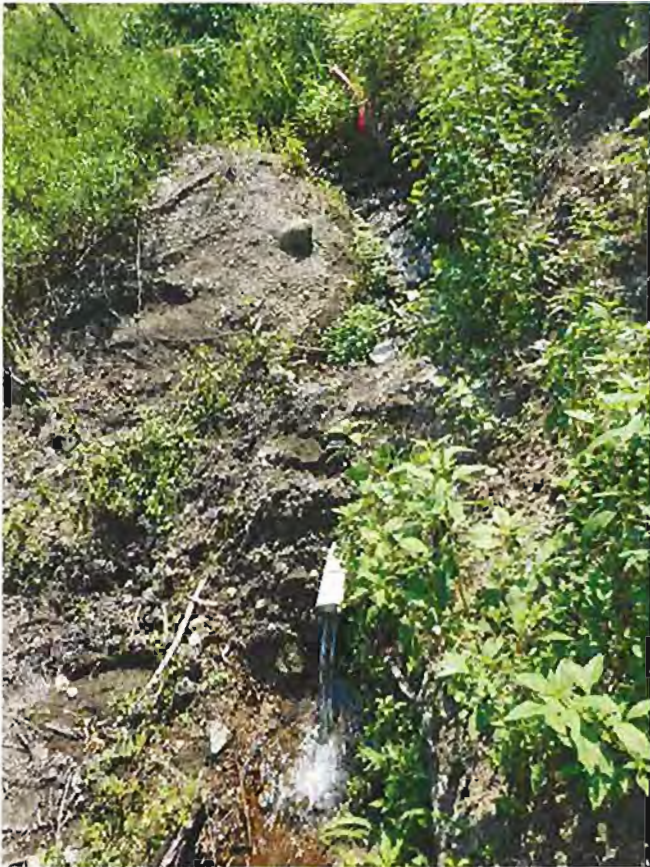
**Photo 48: Ash Disposal Area #1 – Downstream of northeast dike downstream toe, note seeps / natural springs, looking southeast**
